Coatings and Overlays for Concrete Affected by Alkali-Silica Reaction

E.R. Giannini, A.F. Bentivegna, K.J. Folliard
University of Texas at Austin, Austin, Texas, USA

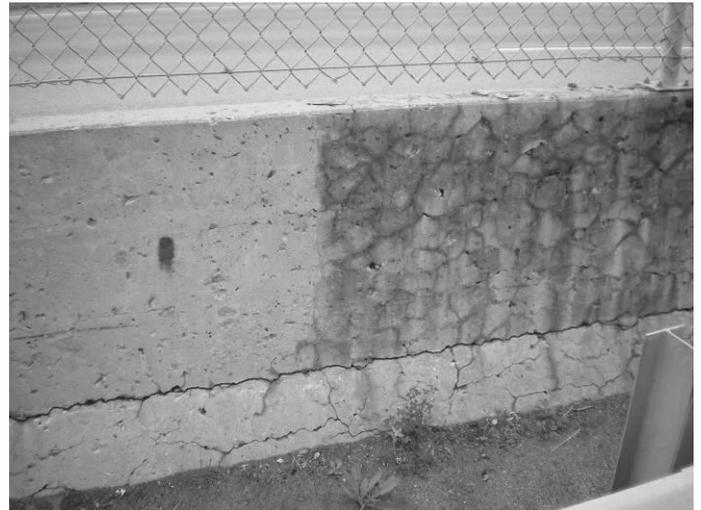
Figure 2. Silane-treated (left) and untreated control (right) median barrier segments near Québec City, Canada.

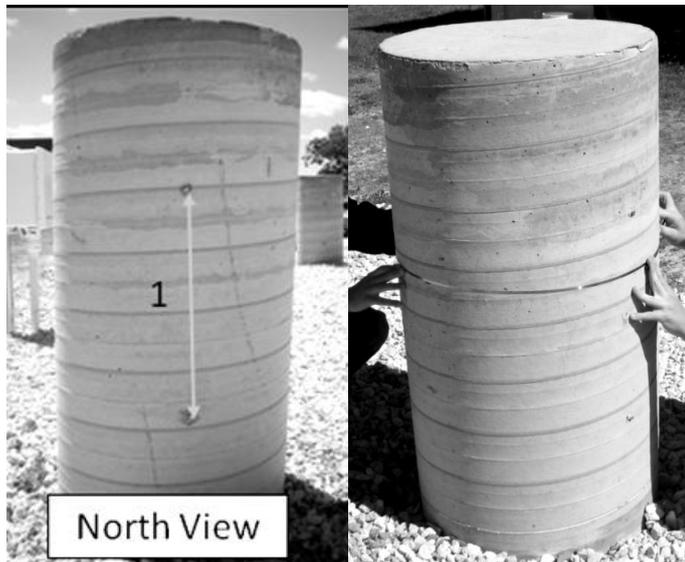
Figure 7. Column expansion measurements. 500 mm vertical gauge length (left) and circumference measurement (right). (Bentivegna 2009).

The specimens were instrumented for measuring expansions and for selected specimens, relative humidity. Visual inspection of the specimens was frequently conducted as well. Embedded stainless steel gauge studs were installed on 500 mm gauge lengths for most expansion measurements and monitored using a DEMEC gauge. For the slabs and bridge decks, three horizontal gauge lengths on two sides of the specimens, in addition to four gauge lengths on the top surface (Fig. 6). The gauge lengths on the sides of the slabs were located at depths of 64, 143 and 222 mm from the top surface, while those on the bridge decks were 51, 105 and 184 mm from the top surface. Two vertical gauge lengths were monitored on opposite sides of the columns (Fig. 7). Additionally, circumferential expansion of the columns was

monitored using a stainless steel tape marked with a vernier scale with 0.03 mm precision (Fig. 7).
