TECHNICAL ARTICLE

CORROSION TESTS ON CRACKED CONCRETE BEAMS

Adapted from ASTM G109

JULY 2018 / VERSION 2 / SIKA SERVICES AG / MICHEL DONADIO

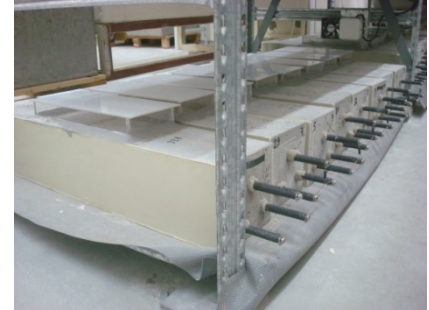
The test specimens are concrete beams of the size 150 x 150 x 750 mm (6 x 6 x 30 in) with three embedded 12 mm diameter mild steel rebars. Two rebars are placed 38 mm (1.5 in) from the bottom of the beams, the third 43 mm (1.7 in) below the top surface of the beams.

After curing the specimens in a humidity chamber for 28 days and then subsequent storage for a month at approximately 23°C, a 5 mm (0.2 in) deep and 3 mm (0.1 in) wide groove was sawn into the top of the mini-beams. The resulting concrete cover, measured below the notch, is 38 mm (1.5 in).

The sides and the bottom of the beams were coated with two coats of epoxy resin (Sikagard®-63) in order to limit water evaporation (simulation of a bridge or parking garage deck) and to prevent contamination from spills of chloride solution during cyclic ponding.

The bottom rebars were permanently connected to each other with 1.0 mm diameter copper wire, and the top rebars are electrically short-circuited using a 10-ohm resistor soldered to the copper wire.

A Plexiglas dyke, 305 mm long, 114 mm wide and 51 mm deep, is attached to the top surface of the cracked beams and sealed with SikaBond AT-14. The dyke is used to expose the beams to a 3.0% (5.0%) by mass solution of sodium chloride using a 2-week wet, 2-week dry ponding cycle procedure. During the wet cycle, the dyke is filled to within 20 mm off the top with sodium chloride solution. The dyke is covered with a plastic plate in order to avoid water evaporation.

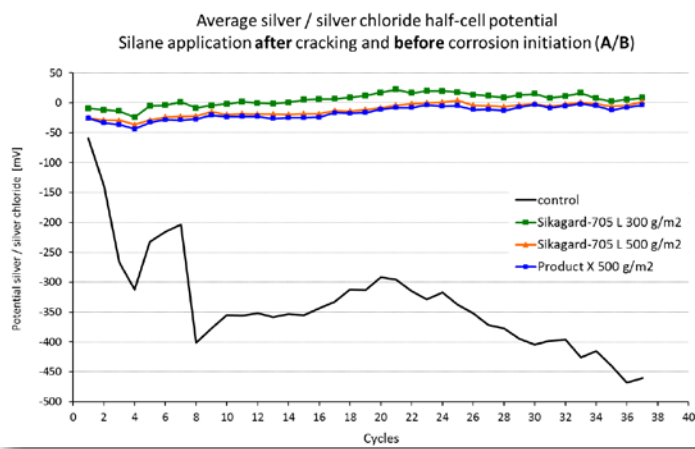
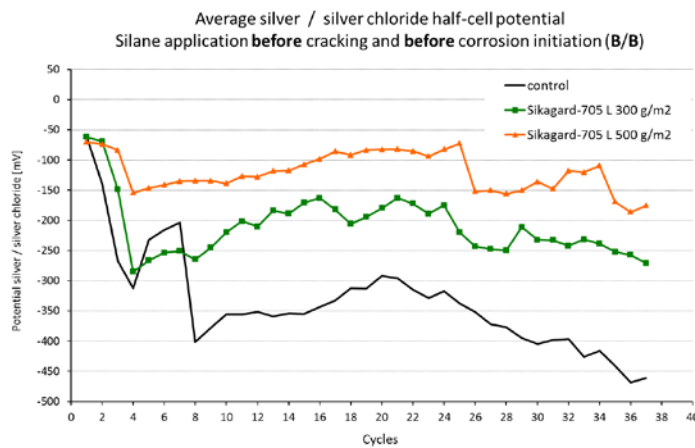
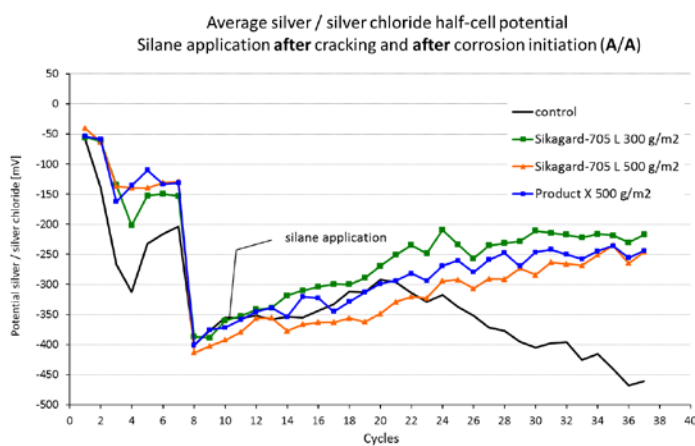
3.1 HALF-CELL POTENTIAL

The half-cell potential or open circuit potential is an indicator of the top rebar's electrochemical tendency to corrode. The potential is measured in the middle of the ponding cycle between the top rebar and a silver/silver chloride reference electrode immersed into the dike filled with sodium chloride solution. It's important to note that this corrosion potential data gives no direct indication on the amount of corrosion taking place, or the exact location of the corrosion.

According to the standard ASTM C876-09 'Standard Test Method for Half-Cell Potentials of Uncoated Reinforcing Steel in Concrete'[3], rebar corrosion potentials of -200 and -350 mV, measured against a copper/copper sulphate sat. electrode (CSE), represent the boundaries of possible corrosion. Rebar potential values more negative than -350 mV CSE indicate probable corrosion, whereas potential values less negative than -200 mV CSE indicate probable lack of corrosion. The corresponding values for the rebar potentials measured against a silver/silver chloride sat. electrode (SSE) are -80 mV SSE and -230 mV SSE.

The graph clearly shows that regardless of the consumption rate (300 or 500 g/m²) or the product used (Sikagard-705 L or Product X), the steel reinforcement bars remain in a full passive environment with no risk of corrosion.

This is clearly shown in the graph but as well in the reduction of the potential versus the control and by the visual examination of the reinforcement steel bars at the end of the cycles.

The graph clearly shows that the hydrophobic impregnation tested still maintains a significant reduction of the potential. In addition it is obvious the influence of the consumption – higher rate of application yields to an higher reduction of the corrosion (seen in the graph and in the visual examination at the end of the cycles).

The graph shows an increase of the potential toward more passive conditions. This is also reflected in the electrochemical measurement at the end of the cycles comparatively to the control specimens. The visual examination is less significant as at when the products were applied, corrosion was already advanced and obviously this treatment does not reverse the process.

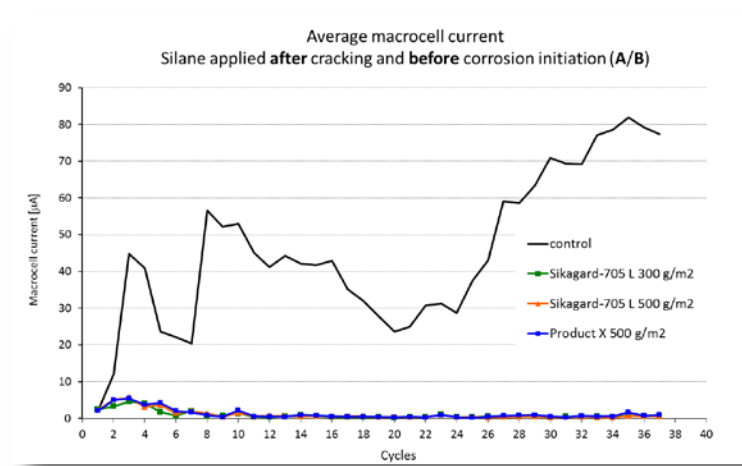
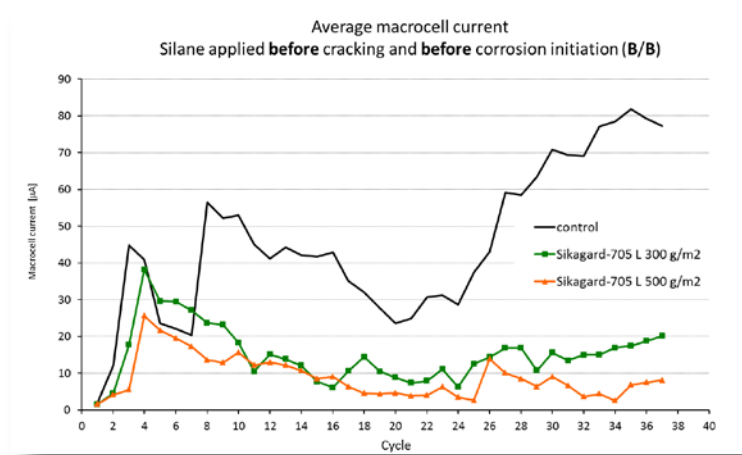
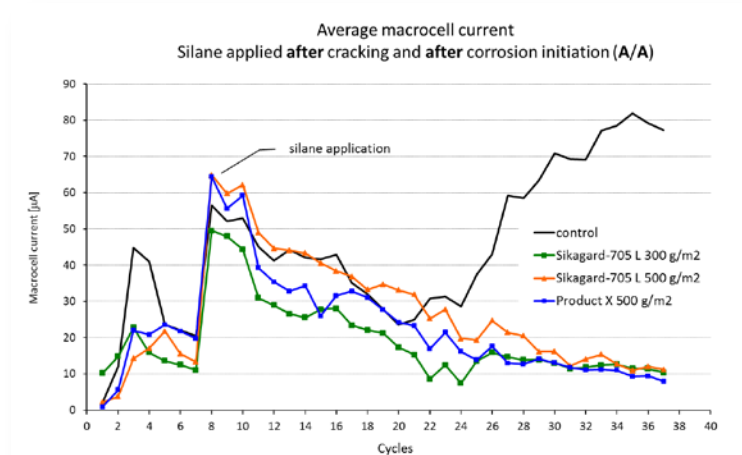
3.2 CORROSION CURRENT

The corrosion current is a direct indicator of the amount of corrosion taking place, and as such, is a direct indicator of the magnitude of metal loss in the corroding rebar. The corrosion current is calculated using Ohm's Law, $U = I \times R$, after measuring the corrosion-induced voltage across a high-grade 10-ohm resistor connecting the presumed anodic and cathodic rebars.

There is a good correlation between measured corrosion currents and the amount of deterioration observed in the post-testing visual inspection of cracked concrete beam test specimens. It must be noted, however, that corrosion currents determined during the test period represent only a portion of the total corrosion taking place, as small micro-corrosion cells involving anodic and cathodic areas on the top rebar will not be measured by this technique. This may be especially important for cracked concrete beams, as only a small portion of the top rebar is directly exposed to sodium chloride solution.

The graph clearly shows that regardless of the consumption rate (300 or 500 g/m²) or the product used (Sikagard-705 L or Product X), corrosion activity remains close to nil as these products prevent effectively the chloride to migrate within the cracks.

This is also confirmed by the visual examination at the end of the study where the reinforcing steel did not show any sign of pitting or corrosion except some corrosion traces in one of the beams where Product X was applied.

The graph clearly shows the same trend as for the Half-Cell potential graph highlighting the importance of penetration depth of the hydrophobic impregnation.

The graph shows a tendency to reduce the corrosion regardless of the consumption rate (300 or 500 g/m²) or the product used (Sikagard-705 L or Product X).

This significant reduction of the macrocell current flow (~85 to 90%) could be explained by the reduction of water penetration due to the protection induced by the silane treatment and by drying of the concrete surrounding the reinforcing steel. This behaviour has been described by E.R. Giannini[6] to explain the reduction of alkali silica reaction when the concrete is being treated by silane products.

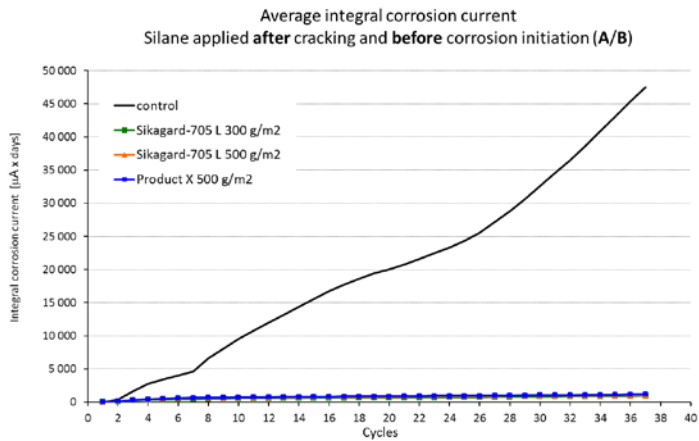
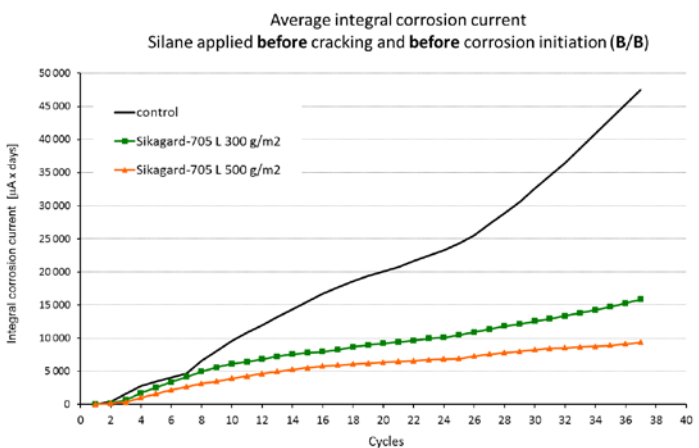
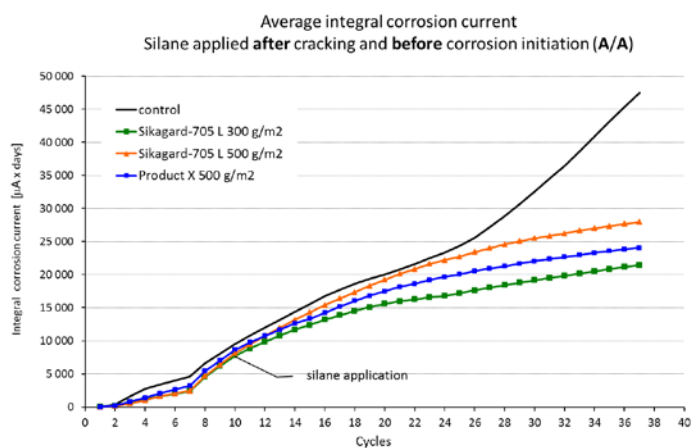
3.3 INTEGRAL CORROSION CURRENT

The integral corrosion currents show performance trends of the corrosion-inhibiting effect of the tested hydrophobic impregnating agents and the cumulative differences in the corrosion currents of different test specimens. This directly reflects the total amount of corrosion which has taken place, i.e. the total metal loss due to rebar corrosion. The integral corrosion current values were computed as the areas under the corrosion current vs. time diagram.

This way of integration assumes linear corrosion currents between consecutive measurements. It doesn't take into account the change in the corrosion current of specimens during the wet-dry cycling, but allows an easy comparison of the cumulative performance of different test samples

The values were computed as the area of the bar graphs under the corrosion current vs. time diagram. This integration assumes a linear corrosion current between consecutive wet cycles. It does not take into account any changes in the corrosion currents of the specimens during the wet and the dry cycles, but allows an easier comparison of the cumulative performance of different hydrophobic impregnating agents and consumptions.

The graph clearly shows that regardless of the consumption rate (300 or 500 g/m²) or the product used, the concrete specimens are still in the corrosion initiation phase while the non-treated specimens are in the corrosion propagation phase as described by Tuutti [7].

The graph clearly shows the corrosion has started in the treated specimens, but the slope of the corrosion is much lower than the one of the control and also that it is dependent on the consumption used.

The same trend of corrosion reduction is observed for the three treated specimens.

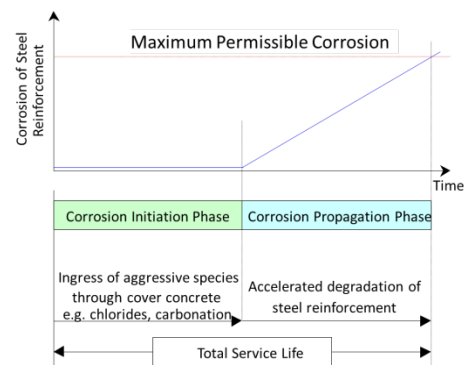
Simplified model of 2-stage corrosion process for steel reinforced concrete structures (after Tuutti)

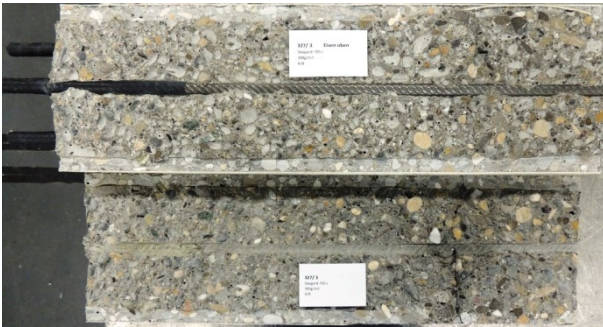
No sign of corrosion in specimen treated by Sikagard-705 L applied **AFTER** cracking & **BEFORE** corrosion has initiated

The visual examination of the different specimens confirms the trends and results provided by the electrochemical measurements.

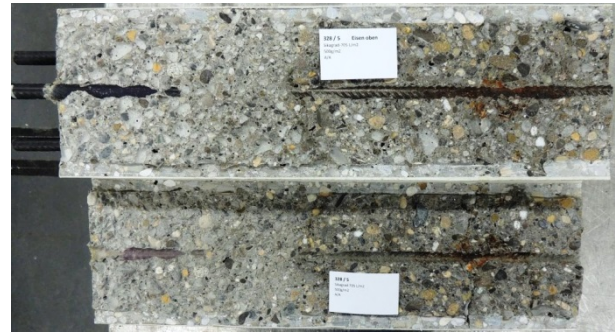
Steel bar with sign of corrosion when treatment is applied after the corrosion has initiated
