Monitoring rebar corrosion propagation in concrete – Results of the Naxberg field experiment after 12 years

Yves SCHIEGG¹, Jan BISSCHOP¹, Stefanie VON GREVE-DIERFELD¹

¹*Technology and Research for Concrete Structures (TFB AG), 5103 Wildegg, Switzerland
-schiegg@tfb.ch -*

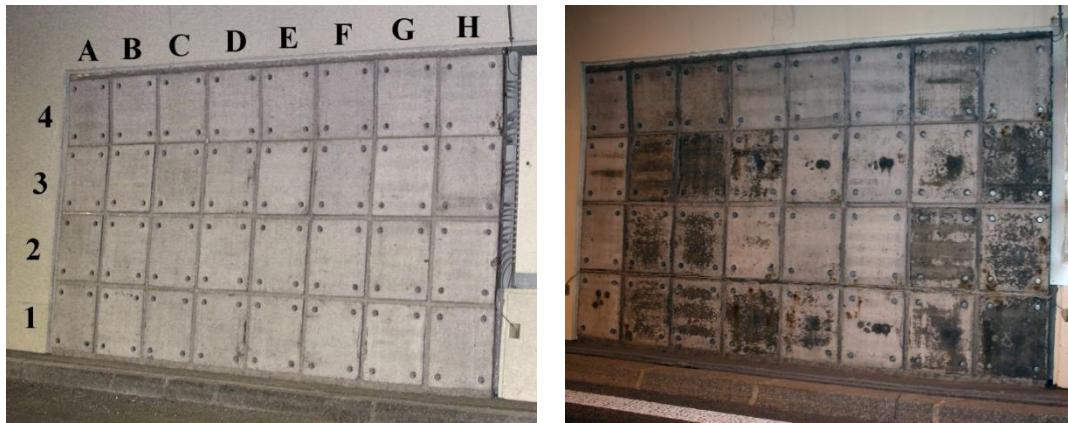
Fig. 1. Visual state of test panels in Naxberg tunnel in year 2000 (left) and 2012 (right).

The Naxberg tunnel is located along the A2 motorway close to the Gotthard tunnel at around 1000 m altitude (asl). As a part of tunnel restoration work at the end of the 1990s, the opportunity was provided to place a concrete test in the tunnel wall at 50-meter distance from the north-facing tunnel entrance (Fig. 1). The panel consists of 32 concrete plates with dimensions of 600 x 500 x 100 mm. The plates were fixed to the wall with four anchor rods made of stainless steel (material no. 1.4529). All electrical connections of the sensors installed in the plates were fed into a measuring box next to the test plates. In this measuring box there are 4 data-loggers for continuous measurements and connections for manual measurements.

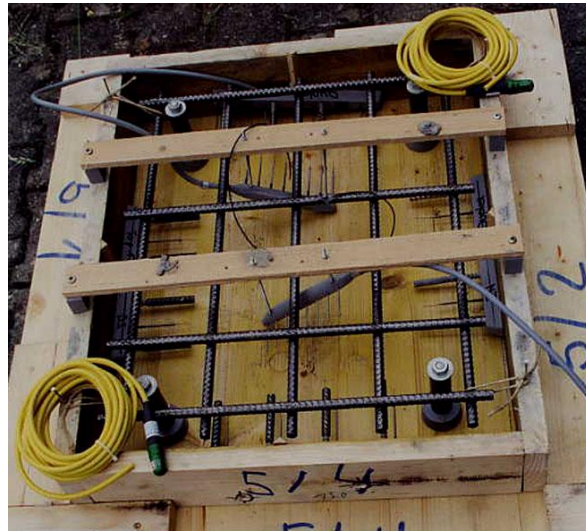
Fig. 2. Instrumentation and reinforcement bars and grid embedded into the concrete plates (see text for explanation). The steel grid is positioned in the rear (wall) side of the plate.

The lowermost concrete plates (numbered with '1') and plates H3, F3 and D3 were instrumented with chloride and resistance sensors for in-situ measurements as well as with reinforcement steel test bars (Fig. 2). The test bars (length ca. 10 cm) were electrically insulated and had varying cover thickness in range of 10-40 mm. The remaining concrete plates also contained the reinforcement test bars, but no further sensors. All concrete plates contained a "cathode" steel grid in the plate side facing the tunnel wall (see Fig. 2).

On the steel samples, the macrocell current was measured between insulated reinforcing bars (anode) and the rear reinforcement grid (cathode) (see Fig. 2, 10). In order to make the data more easily understood, the current intensities were converted into current densities ($\mu\text{A}/\text{cm}^2$) or corrosion rates (mm/year) by using the corroded area measurements (= actual anode surface).

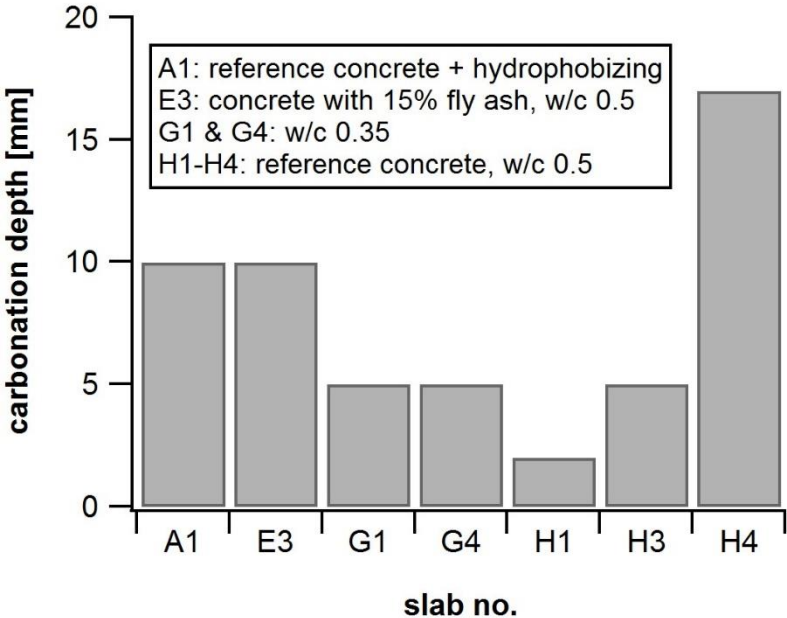
Fig. 5. Carbonation depths measured in various concrete plates after 12 years exposure.

The carbonation depths were measured from the surface of drilled cores (Fig. 5). For the reference concrete (plates H1, H3 and H4 - w/c = 0.5), the carbonation depth increases significantly with height distance from road. The lower plates are most affected by spray water and snow accumulation, and therefore have a high water-saturated degree than the higher plates. The diffusion rate of CO₂ into saturated-concretes is typically lower than for partly saturated or dried concrete. In the case of concrete plate A1 (with hydrophobic treatment), the carbonation depth is significantly greater than in the case of plate H1. The higher carbonation depth is due to the water-repellent effect of the hydrophobic treatment which results in a higher diffusive CO₂-ingress. A comparatively high carbonation depth was measured for plate E3. It appears that the addition of fly ash resulted in a faster carbonation compared to the reference concrete. Approximate carbonation coefficients [1] for plates H1, H3 and H4 of, respectively, 0.7; 1.9; and 6.3 mm/year^{0.4} were obtained from these measurements. The coefficient of the plate H4 is very high, which could be due to an increased CO₂ content of the air in the tunnel. For plate A1 a carbonation coefficient of 3.7 mm/year^{0.4} was determined, which is between the values of the plates H3 and H4.

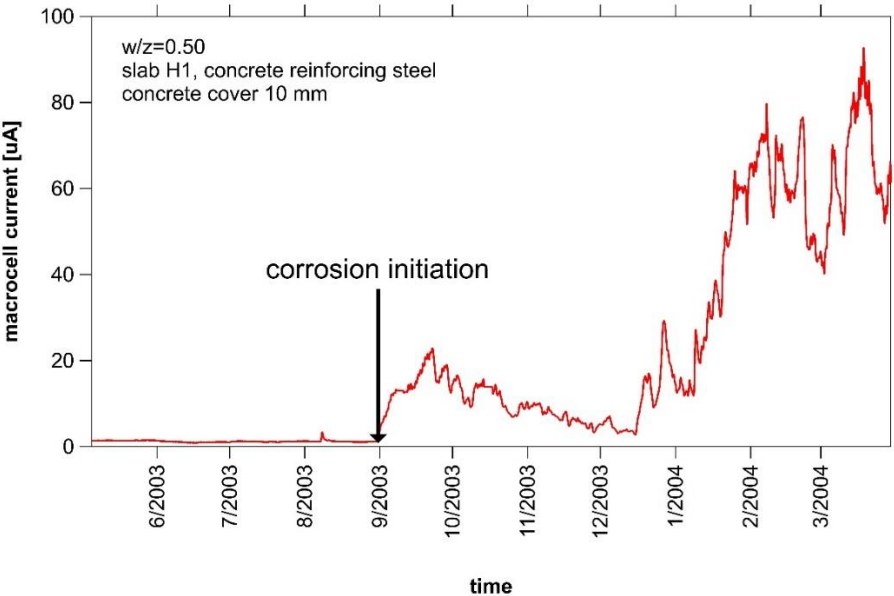
Fig. 7. Evolution of the macrocell current for a B500B rebar in plate H1. From the moment of the corrosion initiation the current increases in a step-wise manner.

The timing of corrosion initiation of the reinforcement could be reliably determined in most cases based on the measured macrocell currents (corrosion currents) and/or by the corrosion potential measurements. As long as the steel sensor is passive, i.e. free of corrosions, no or an extremely low current between the sensor and the rear reinforcement grid (cathode) is recorded. When the critical chloride content is exceeded, a local corrosion attack on the steel is triggered (initiation), which causes the current flow, i.e., macrocell current between the local separated anodes (corrosion site) and cathodes (Fig. 7). The stable initiation of pitting is, in most cases, a process that starts abruptly and leads to a rise in current. Short-term passivation and depassivation processes before the actual breakthrough, as can also be seen in

Fig 7, are typical for pitting corrosion induced by chlorides. After the initiation of the corrosion, a permanent current flow is registered, resulting in a gradual growth of the corrosion pits which is characterized as the corrosion progress.

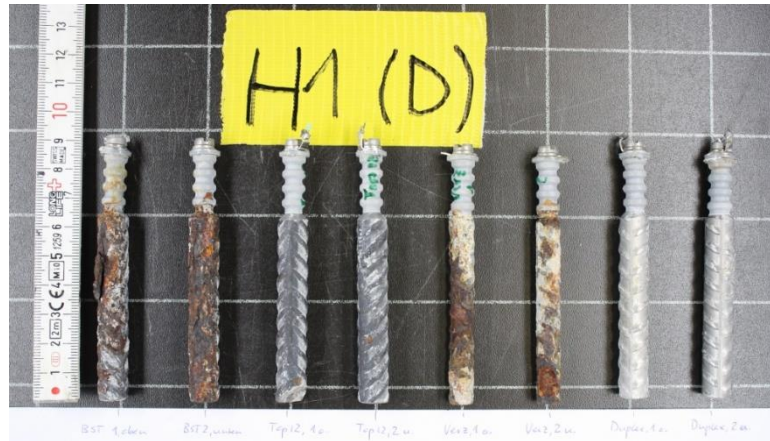
Fig. 8. State of corrosion of the rebars in concrete after 12 years chloride exposure and carbonation for plate H1 with cover thickness of 10 mm. From left to right: 2 x carbon steel B500B; 2 x TOP12; 2 x galvanized B500B; 2 x stainless steel 1.4462.

Some examples of corroded or corrosion-free rebars (at cover depth of 10 mm) in the reference plate H3 are shown in Fig. 8. The carbon steel bars exhibit pitting and over 70% of the steel surface is corroded. This also applied to galvanized carbon steel bars. The zinc coating is virtually completely dissolved, and the underlying steel corroded with pitting. The resistant steel type TOP12 has only a few smaller rust spots without measurable material loss. The stainless- steel type 1.4462 is free of any corrosion signs.

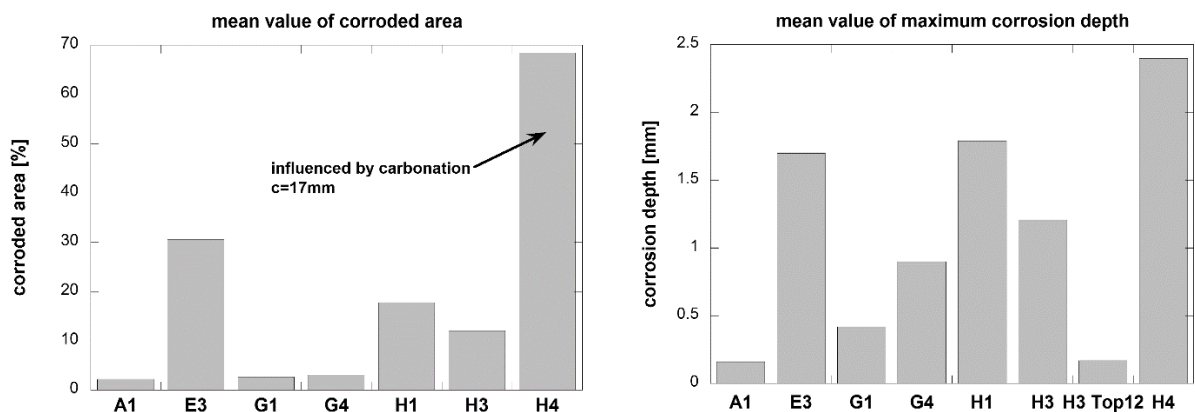
Fig. 9. Average corroded surface fraction and average corrosion depth (max.) of rebars with cover thickness of 10 mm in plate H3.

After removal of rust from the rebar surfaces, the corroded area size and the maximum removal depth were measured using the abovementioned methods. The results of these investigations for the concrete steels with 10 mm cover thickness are shown in Fig. 9. In the case of plate H1 and H3, approximately 18% and, resp. 10% of the steel surfaces are attacked on average. It is striking that the carbon rebar in plate H4 is corroded 70% over its surface, although this plate is above the H1- and H3-plates. This is probably due to the larger carbonation depth, which leads to a combined or intensified corrosion attack together with the chloride ingress. Also in plate E3 (concrete with fly ash) the carbon steel rebars were relatively strongly attacked. The steel bars in plates A1, G1 and G4, on the other hand, had significantly smaller corroded surfaces and the corrosion pitting was less deep.

The average maximum corrosion depths correlate roughly with the corroded surface fraction (see Fig. 9). In the Plate A1 with hydrophobic treatment (and little chloride ingress), the carbon steel bars had relatively low corrosion degree (area and depth). The Top12-rebar in Plate H3 showed little corrosion depth as well.

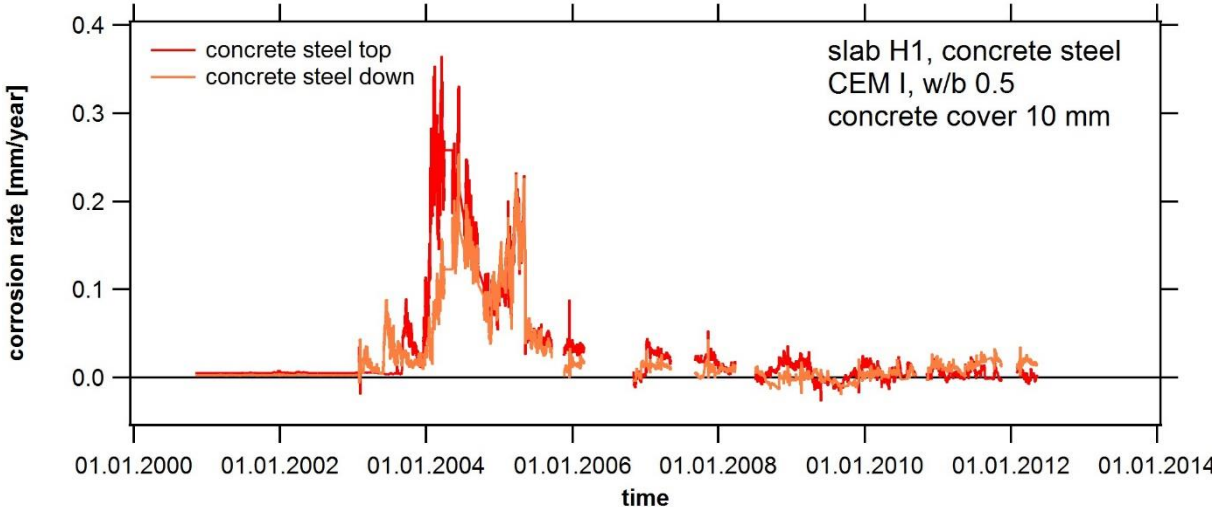
Fig. 10. Corrosion rate for two carbon steel bars in plate H1.

The corrosion rate increased sharply after initiation (after about two years into the field experiment). The short-term fluctuations in the corrosions rate (i.e., peaks) are likely a result of the temperature fluctuations of the concrete. In the summer months of 2004 and 2005 (warm temperatures), the corrosion rate is maximum, before it drops to below 0.1 mm/year and stabilizes for the next 6 years. Possible contributing cause of this drop in corrosion rate is the activation of the rear reinforcement grid, which reduces the passive cathodic performance of the grid reinforcement. The corrosion initiation of the deeper steel bars could also have led to a reduction in the corrosion rate of the top steel bars. The macrocell current can be converted into a mass loss over a certain time period by integrating the Faraday equation:

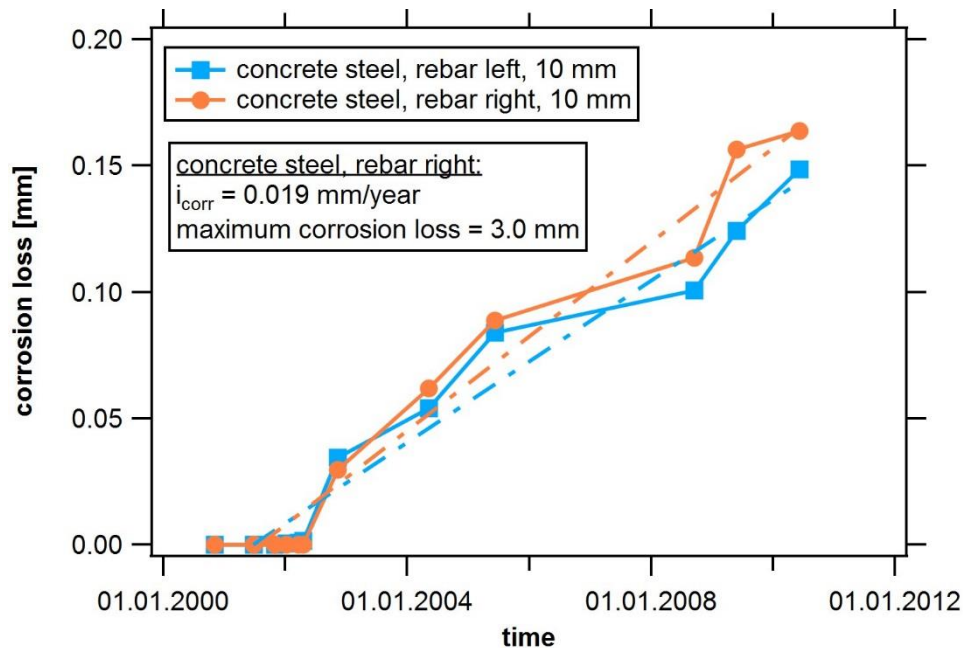
Fig. 11. Progression of average corrosion depth for two carbon steel bars in plate H1.

Fig. 11 shows the corrosion propagation (depth) of two carbon steel bars with a concrete cover of 10 mm in plate H4 (manual measurement). For the calculations, it was assumed that the measured corrosion area fraction represents the effective anode area size. For the ‘left’ carbon steel bar, the anode area was around 50% of the bar surface, whereas for the ‘right’ carbon steel bar this was 86%. The stepwise manner of the increase in corrosion depth is

probably related to temperature fluctuations. During the warm summer months, the corrosion rate is higher than in winter, because the electrical concrete resistance decreases with increasing temperature. Moreover, the moisture content of the concrete, accumulated in the winter, will be still high in (the beginning of) summer and facilitates corrosion. The average corrosion rate of the two reinforcing bars is comparable. For the ‘right’ carbon steel bar it is 0.019 mm/year (= 19 $\mu\text{m}/\text{year}$), whereas for the ‘left’ carbon steel bar the corrosion rate is slightly lower. The total steel removal calculated for these bars was about 0.15 mm after 9 years.

In practice, the anode area size as well as the corrosion depth increases with time. At the moment of initiation, the anode area is very small. With ongoing corrosion, the pits grow and expand into large cavities, and the corrosion depth increases as well. The assumption of a constant anode area size, on which the calculations in Fig. 11 are based, does therefore not correspond to reality.

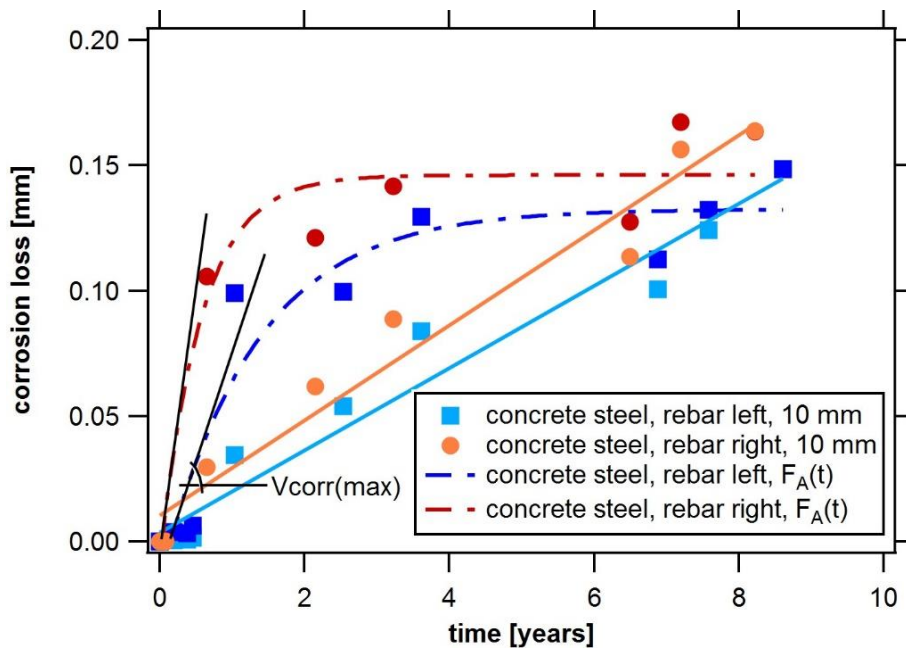
Fig. 12. Progression of average corrosion depth for two carbon steel bars in plate H1 calculated on basis of assumed constant (conf. Fig. 11) or increasing anode area size F_A .

Fig. 12 shows the progress in the corrosion depths for two carbon steel bars in the plate H4 with assumed constant and \sqrt{t} -increasing anode area size. For the case of an increasing anode surface, the corrosion depth initially increases sharply and gradually stabilizes after about four years. The constant anode surface assumption leads to a more or less linear corrosion removal rate. By applying tangents to the growth curves, the maximum corrosion rate can be determined. For the ‘left’ rebar this is about 70 $\mu\text{m}/\text{year}$, which is a factor of 3.7 larger than the one determined for the linear growth assumption. For the ‘right’ rebar, the maximum corrosion rate was 260 $\mu\text{m}/\text{year}$. This is a factor of 10 times larger than in the linear case assumption for this sample. Corrosion rates in the range of 0.2 to 0.3 mm/year are plausible for comparable, heavily chloride-contaminated structures, as was also documented in earlier work [6].
