TECHNICAL ARTICLE

CORROSION TESTS ON CRACKED CONCRETE BEAMS

Adapted from ASTM G109

JULY 2018 / VERSION 2 / SIKA SERVICES AG / MICHEL DONADIO

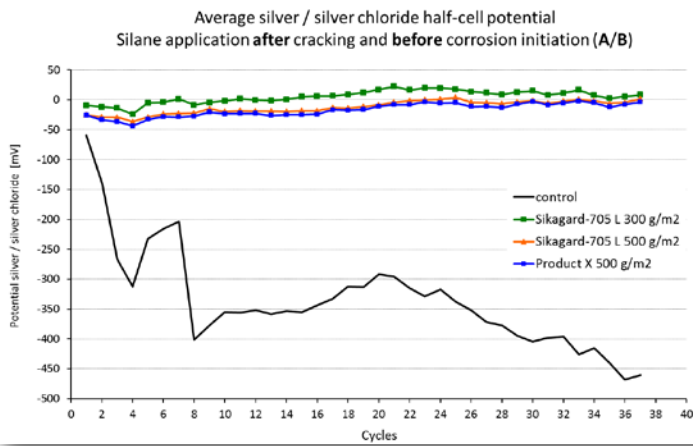
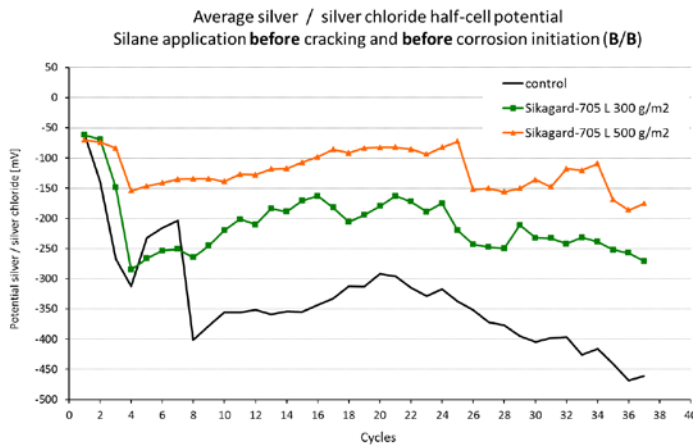
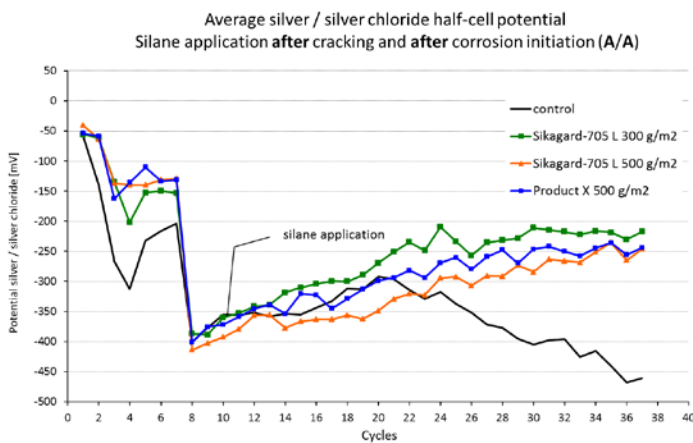
3.1 HALF-CELL POTENTIAL

The half-cell potential or open circuit potential is an indicator of the top rebar's electrochemical tendency to corrode. The potential is measured in the middle of the ponding cycle between the top rebar and a silver/silver chloride reference electrode immersed into the dike filled with sodium chloride solution. It's important to note that this corrosion potential data gives no direct indication on the amount of corrosion taking place, or the exact location of the corrosion.

According to the standard ASTM C876-09 'Standard Test Method for Half-Cell Potentials of Uncoated Reinforcing Steel in Concrete'[3], rebar corrosion potentials of -200 and -350 mV, measured against a copper/copper sulphate sat. electrode (CSE), represent the boundaries of possible corrosion. Rebar potential values more negative than -350 mV CSE indicate probable corrosion, whereas potential values less negative than -200 mV CSE indicate probable lack of corrosion. The corresponding values for the rebar potentials measured against a silver/silver chloride sat. electrode (SSE) are -80 mV SSE and -230 mV SSE.

The graph clearly shows that regardless of the consumption rate (300 or 500 g/m²) or the product used (Sikagard-705 L or Product X), the steel reinforcement bars remain in a full passive environment with no risk of corrosion.

This is clearly shown in the graph but as well in the reduction of the potential versus the control and by the visual examination of the reinforcement steel bars at the end of the cycles.

The graph clearly shows that the hydrophobic impregnation tested still maintains a significant reduction of the potential. In addition it is obvious the influence of the consumption – higher rate of application yields to an higher reduction of the corrosion (seen in the graph and in the visual examination at the end of the cycles).

The graph shows an increase of the potential toward more passive conditions. This is also reflected in the electrochemical measurement at the end of the cycles comparatively to the control specimens. The visual examination is less significant as at when the products were applied, corrosion was already advanced and obviously this treatment does not reverse the process.

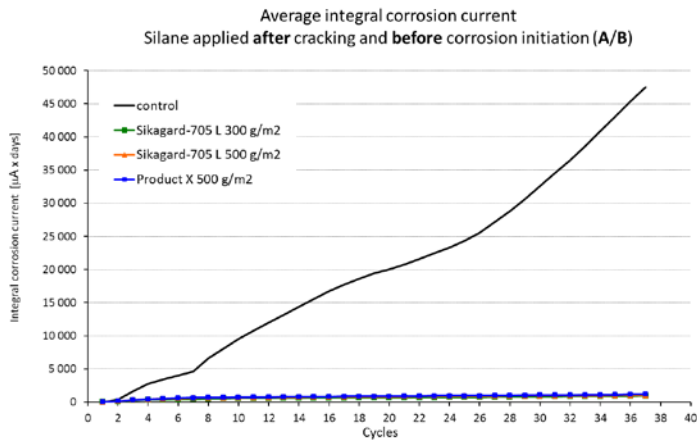
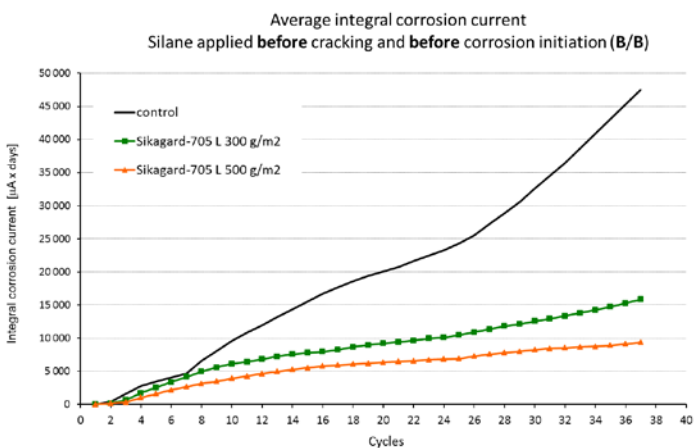
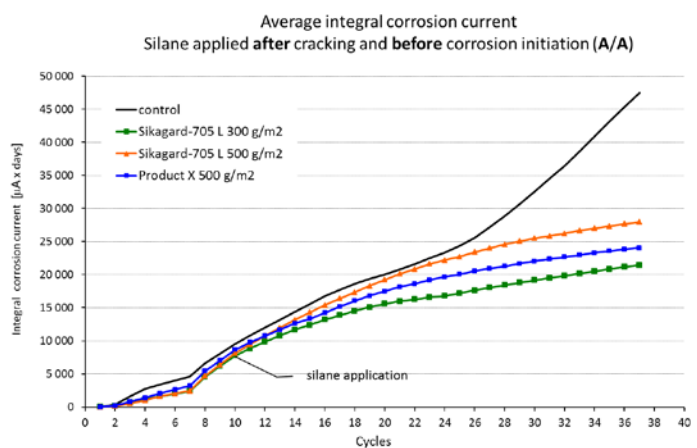
3.3 INTEGRAL CORROSION CURRENT

The integral corrosion currents show performance trends of the corrosion-inhibiting effect of the tested hydrophobic impregnating agents and the cumulative differences in the corrosion currents of different test specimens. This directly reflects the total amount of corrosion which has taken place, i.e. the total metal loss due to rebar corrosion. The integral corrosion current values were computed as the areas under the corrosion current vs. time diagram.

This way of integration assumes linear corrosion currents between consecutive measurements. It doesn't take into account the change in the corrosion current of specimens during the wet-dry cycling, but allows an easy comparison of the cumulative performance of different test samples

The graph clearly shows that regardless of the consumption rate (300 or 500 g/m²) or the product used, the concrete specimens are still in the corrosion initiation phase while the non-treated specimens are in the corrosion propagation phase as described by Tuutti [7].

The graph clearly shows the corrosion has started in the treated specimens, but the slope of the corrosion is much lower than the one of the control and also that it is dependent on the consumption used.

The same trend of corrosion reduction is observed for the three treated specimens.
